## The Glitch

*Overview:* A solar combisystem is being planned to provide a portion of the space heating and domestic hot water needs of a new “Eco” house being constructed in Vermont. The house will have plenty of south-facing windows to help warm it on sunny winter days.

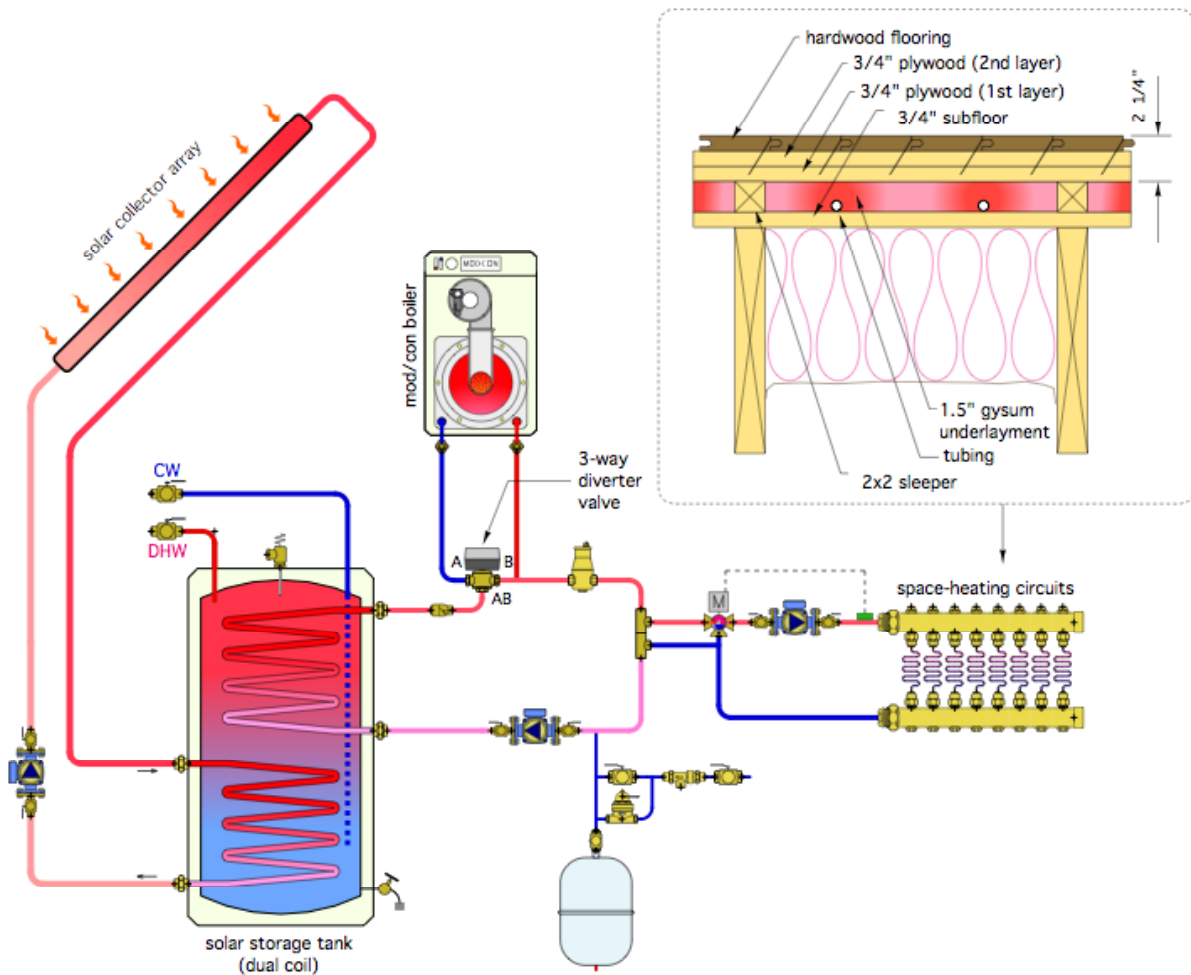
The owner loves the idea of warm floors, but also wants nail-down hardwood flooring. The flooring contractor plans to install that floor as shown in the cross-section below (because he saw this detail in a major home building publication).

*Exercise:* Look over the schematic and the planned floor installation detail. Do you see any problems lying in wait?

The flooring installation detail shown did appear in a major building publication. It's the result of asking a flooring specialist (rather than a heating specialist) how the flooring should be installed over a radiant panel.

The flooring installer doesn't want any issues with keeping that floor flat, so he specifies two overlapping layers of 3/4" plywood for the underlayment. This adds considerable thermal resistance between the water in the tubes and the top surface of the floor. This significantly increases supply water temperature, especially at design load conditions.

Although such a floor would probably operate adequately at design load conditions if supplied with water in the 160 °F range, such temperatures are quite presumptuous for a solar system using flat plate collectors during a cold Vermont winter. The solar energy contribution to space heating in such a system will be very limited.
